National Transportation Safety Board

In-Flight Fire Data

# SwissAir 111

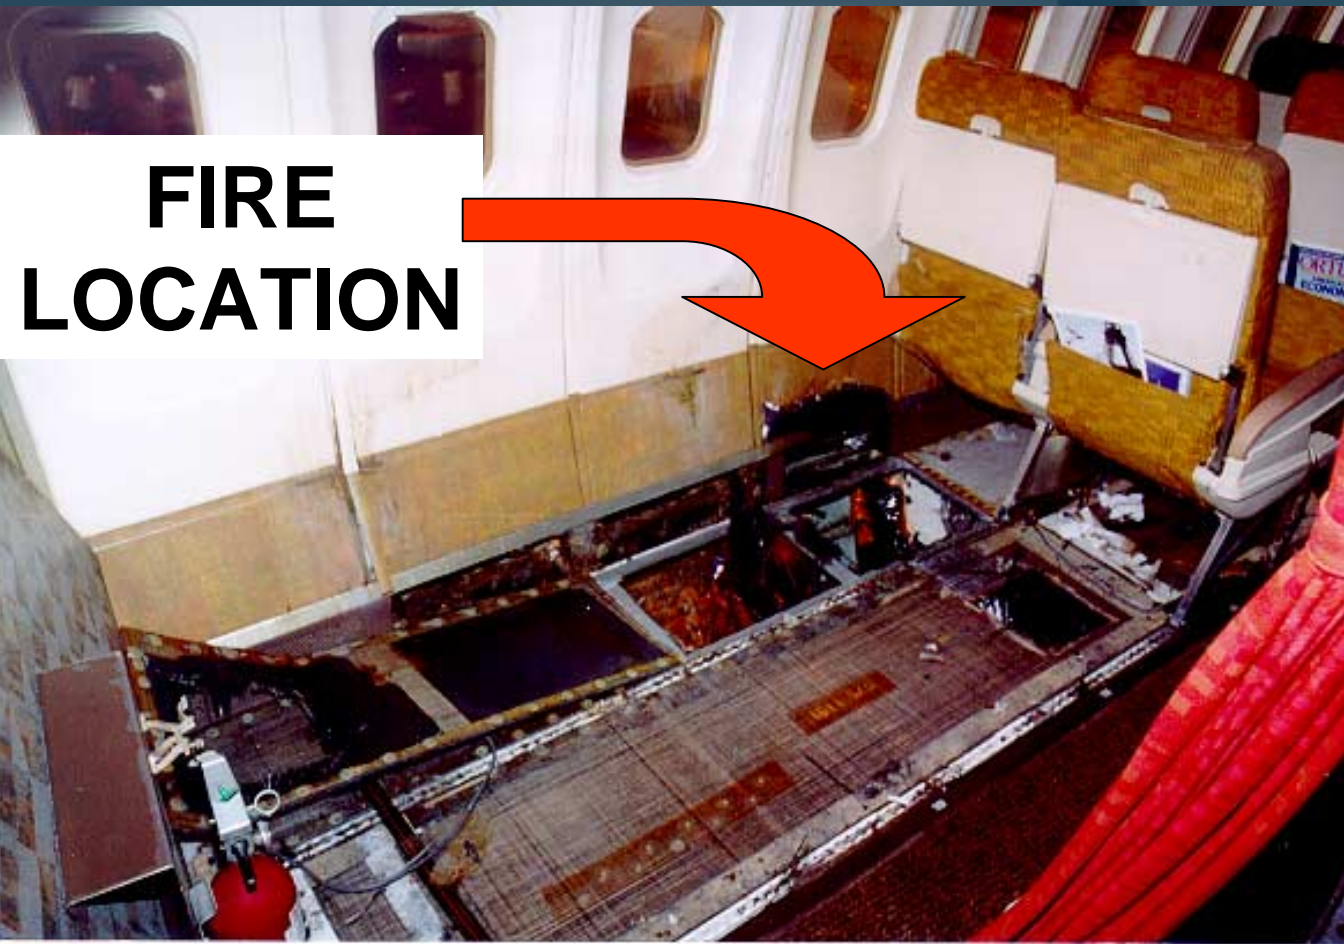
Delta Air Lines L-1011 , March 17, 1991, Near Goose Bay, Canada

- Require quality control & inspection procedures for wire installations.
- Notify FAA personnel and operators about fire hazards posed by accumulations and other debris.
- Require that maintenance manuals be amended to ensure thorough inspection & cleaning.

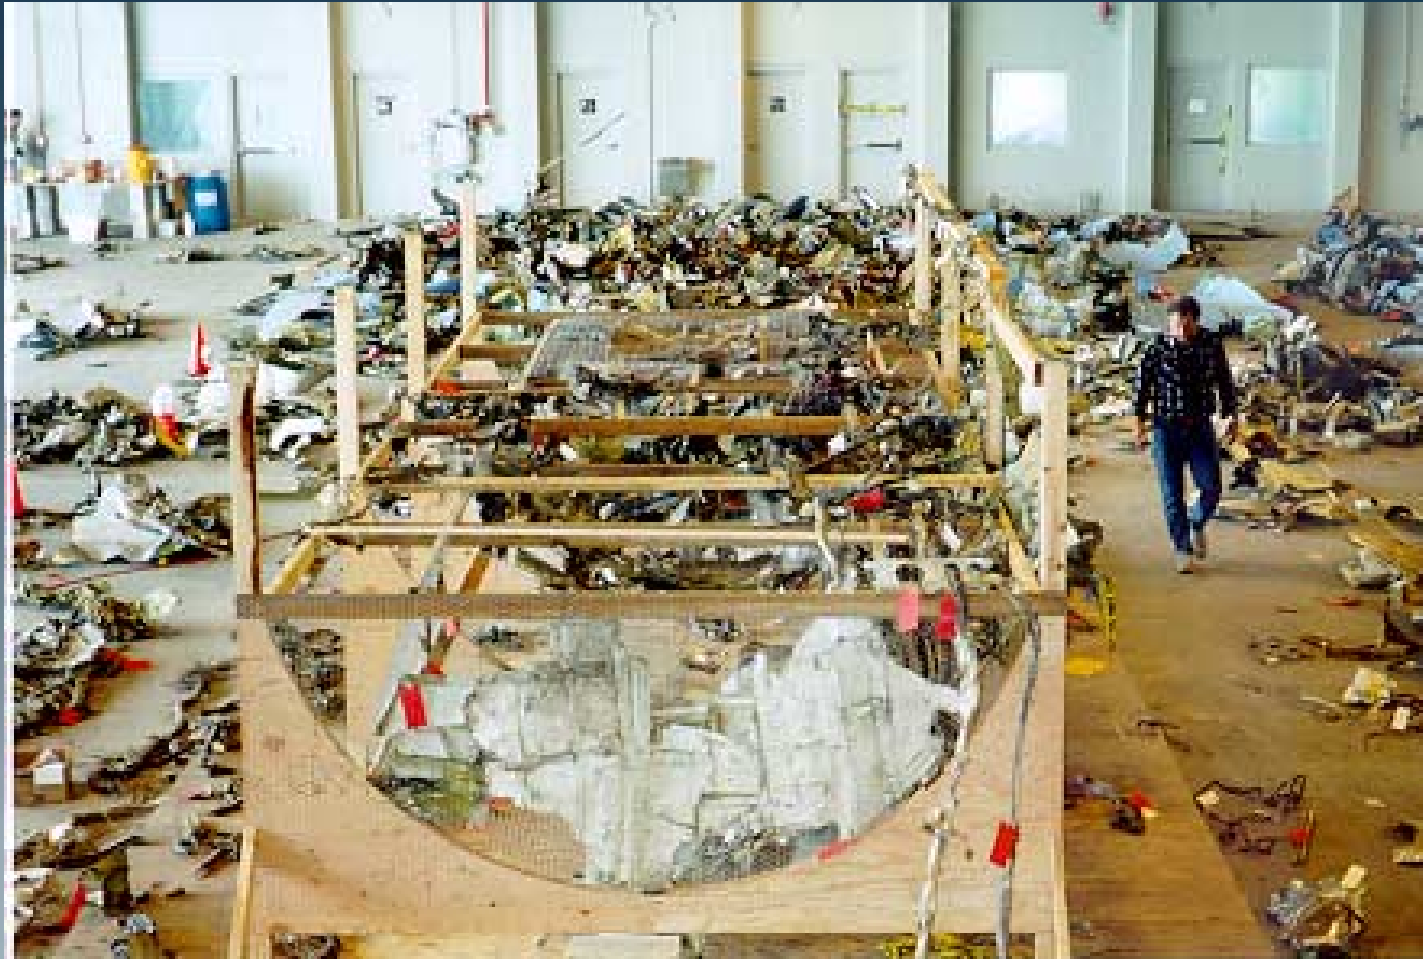
DCA96MA054, VALUJET AIRLINES DC-9, May 11, 1996,  
Everglades, Florida, about 10 minutes after take off.

- ValuJet Safety Issues Included:
- Minimization of the Hazards Posed by Fires in Class D Cargo Compartments;
- Equipment, Training, and Procedures for Addressing In-Flight Smoke and Fire;
